Manhole Inspection Summary

Manhole # S39MM_025MH

Location Address: **2003 ROBB ST**

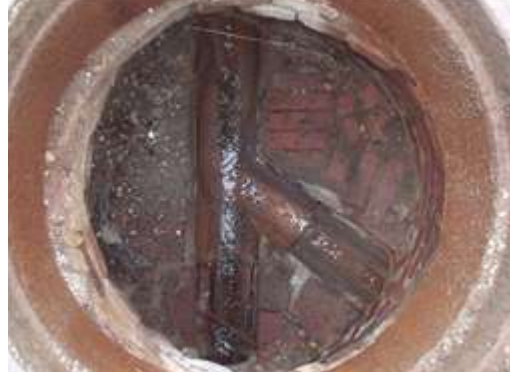
Top View

Bench and Channel debris.

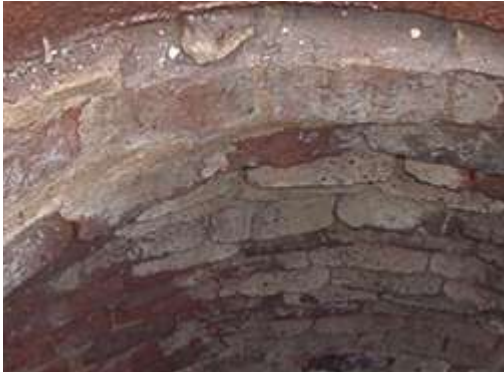
Defect

Frame leaks. Frame offset. Adjustment deterioration and infiltration. Corbel infiltration.

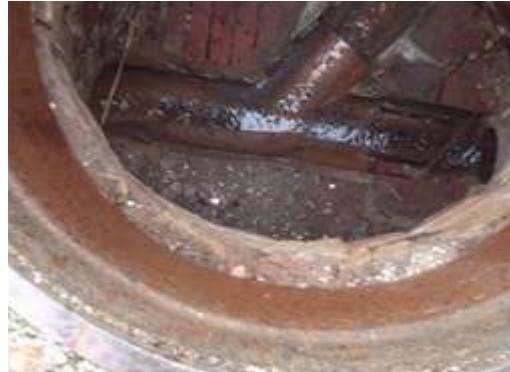
Defect

Frame leaks. Frame offset. Adjustment deterioration and infiltration.

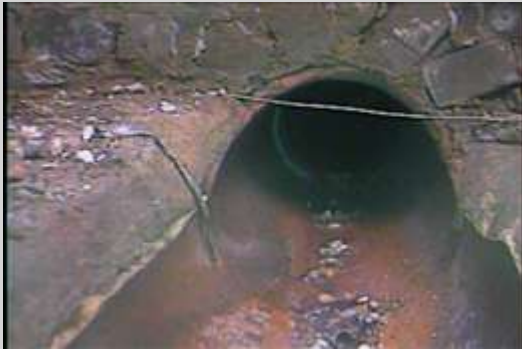
8 in. Circular Gravity Sewer Pipe Out @ 12 O'Clock

Infiltration: **None** Pipe Seal Cond: **Unknown**

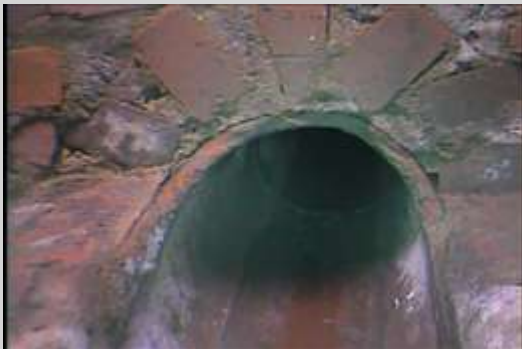
8 in. Circular Gravity Sewer Pipe In @ 4 O'Clock

Infiltration: **None** Pipe Seal Cond: **Unknown**

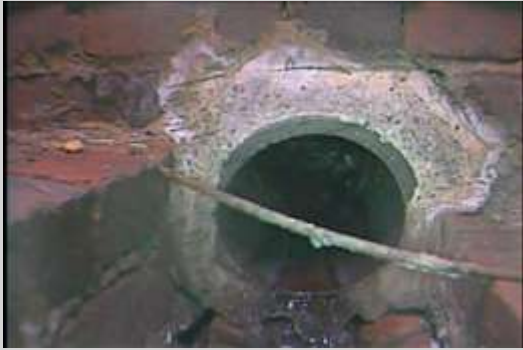
6 in. Circular Gravity Sewer

Infiltration: **None**
